WOOD DESTROYING PESTS AND ORGANISMS INSPECTION REPORT

Building No. 128	Street 17TH ST	City RICHMOND	Zip 94801	Date of Inspection 02/22/21	Page 1 of 10
----------------------------	--------------------------	-------------------------	---------------------	---------------------------------------	------------------------

Report # 022221-2

General Description: ONE STORY WOOD FRAMED DWELLING	Inspection Tag Posted: SUBAREA
	Other Tags Posted: NONE NOTED

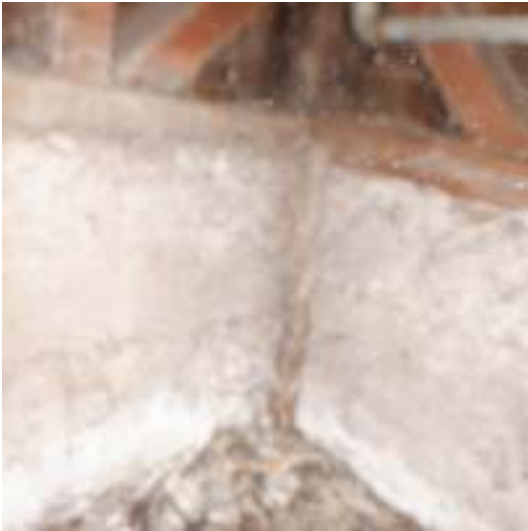
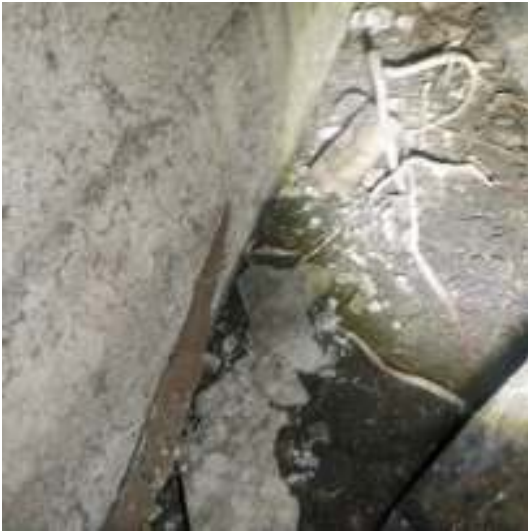
1A:

1A. Forms are fungus damaged.

RECOMMENDATION: Remove and omit. SECTION 1 ITEM

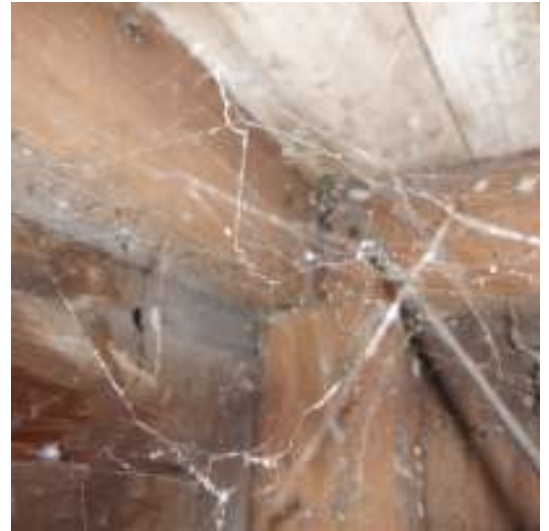
1C:

1C. Fungus damage present to framing and subfloor.

RECOMMENDATION: Repair or replace fungus damaged wood members as necessary and prime paint new wood.

NOTE: SHOULD FLOORING BECOME DAMAGED A SUPPLEMENTAL REPORT WILL BE ISSUED. SECTION 1 ITEM.

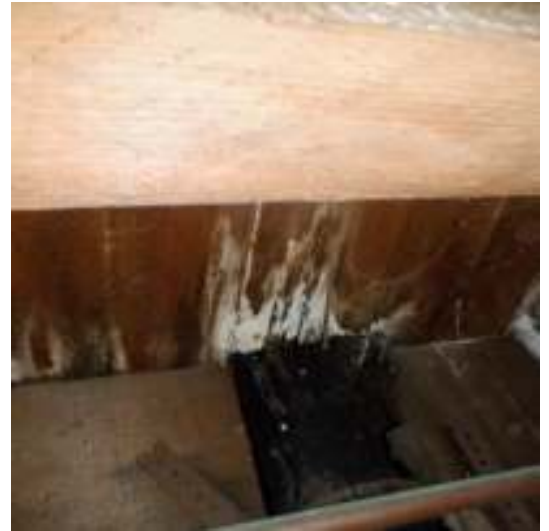
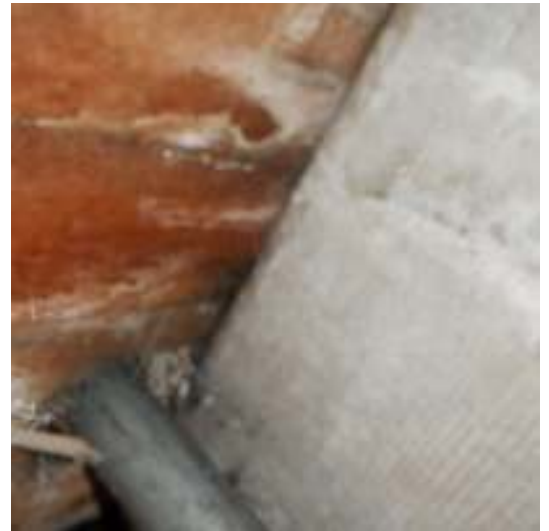
1D:

1D. Surface fungus was noted on the wood members in the subarea.

RECOMMENDATION: Scrape and treat the infected wood members with TIM-BOR, a registered fungicide. (See Chemical Sheet for active ingredients). SECTION 1 ITEM.

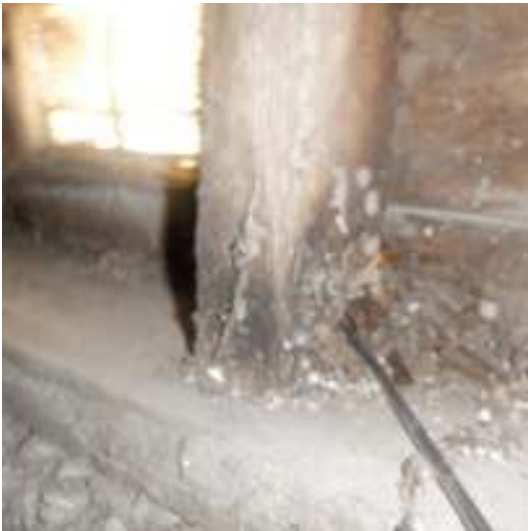
1B:

1B. Fungus damage present to framing.

RECOMMENDATION: Repair or replace fungus damaged wood members as necessary and prime paint new wood. SECTION 1 ITEM.

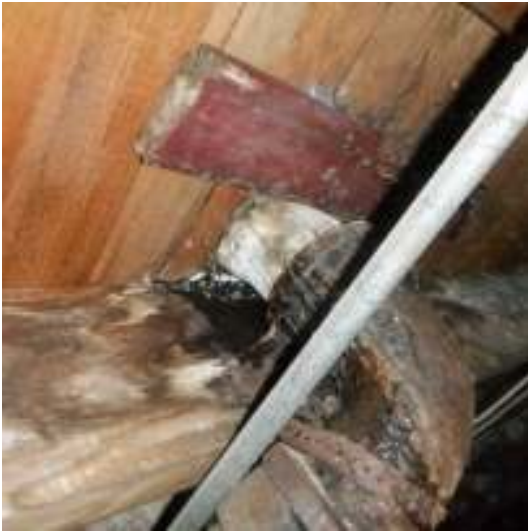
1E:

1E. Floor, in bath, is fungus damaged.

RECOMMENDATION: Remove commode(s) and repair damage as necessary. Install new underlayment with new, neutral color, standard grade linoleum and reset commode(s) on a new wax seal(s). NOTE: IF PRIOR COLOR SELECTION IS NOT MADE, A NEUTRAL COLOR WILL BE INSTALLED. SECTION 1 ITEM

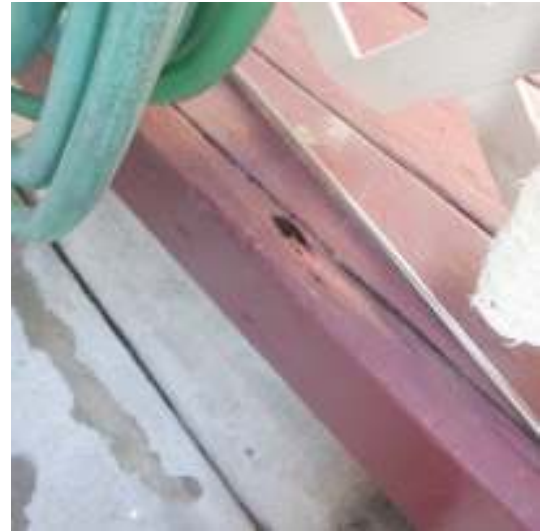
2B:

2B. Fungus damage present to deck trim.

RECOMMENDATION: Repair or replace fungus damaged wood members as necessary and prime paint new wood. SECTION 1 ITEM.

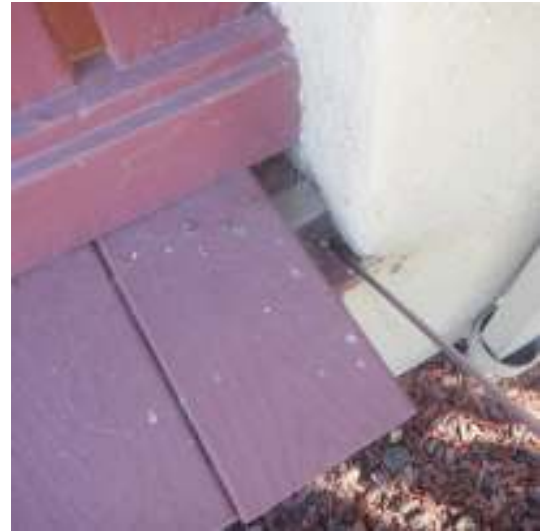
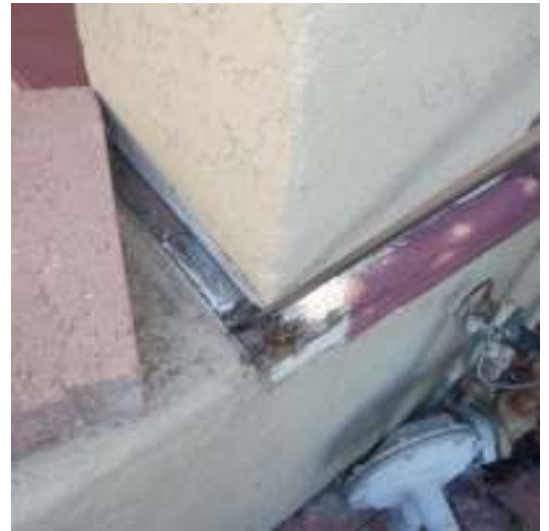
2C:

2C. Fungus damage present to deck framing and steps.

RECOMMENDATION: Repair or replace fungus damaged wood members as necessary and prime paint new wood. SECTION 1 ITEM.

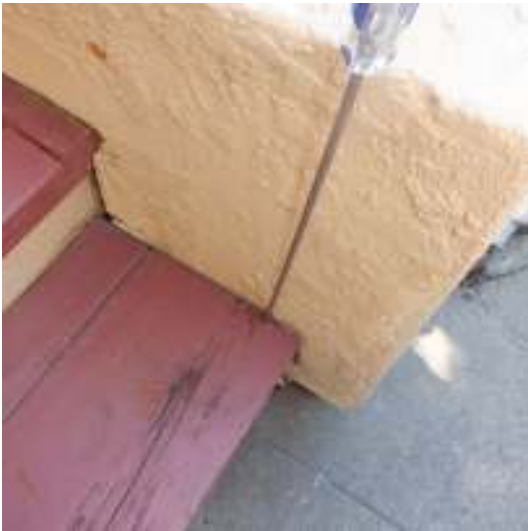
2A:

2A. Fungus damage present to framing.

RECOMMENDATION: Repair or replace fungus damaged wood members as necessary and prime paint new wood. SECTION 1 ITEM.

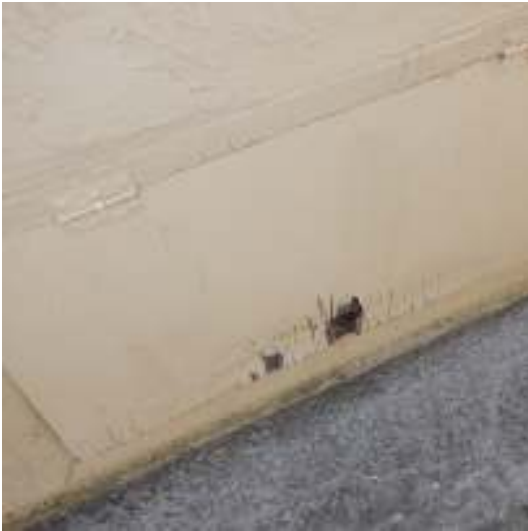
5B:

5B. Fungus damage present to electrical door.

RECOMMENDATION: Repair or replace fungus damaged wood members as necessary and prime paint new wood. SECTION 1 ITEM. (SECTION I ITEM)

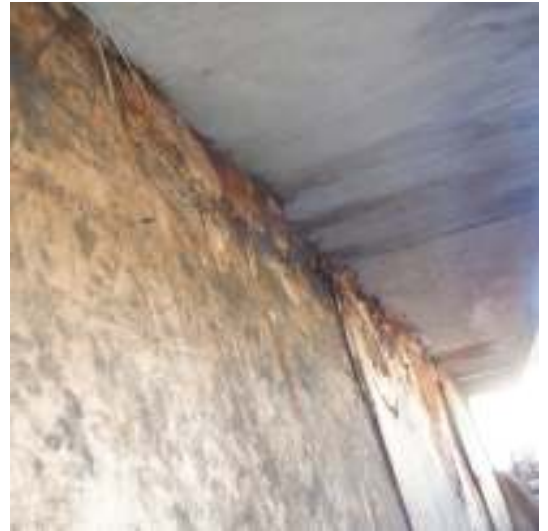
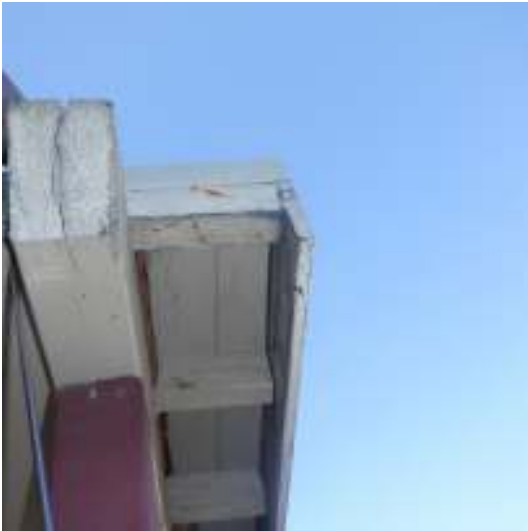
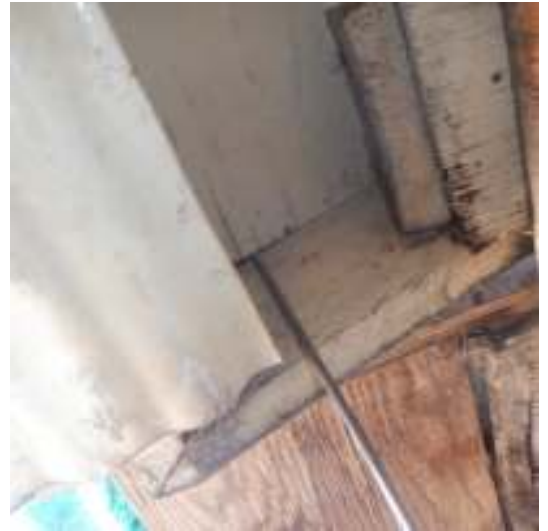
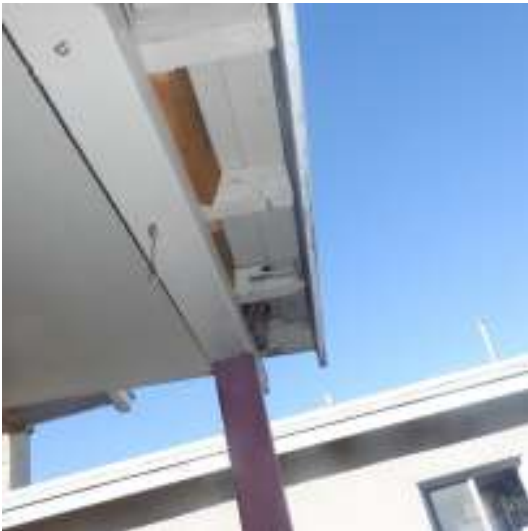
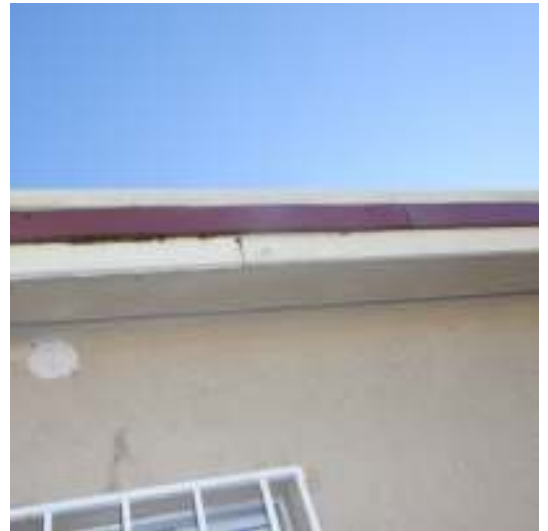
5C:

5C. Fungus damage present to roof framing and sheathing.

RECOMMENDATION: Repair as necessary to eliminate this structural deficiency and prime paint new wood.

Owner to have roof covering patched by a licensed roofing contractor after repairs have been performed. SECTION 1 ITEM. (SECTION I ITEM)
